**Flood Control Project Maintenance
Levee Inspections**

Fall 2012 Levee Maintenance Deficiency Summary Report

Yolo County Service Area 6

Waterway			Bank	Unit Miles
Unit No. 01 Right Bank of Sacramento River at Knights Landing			Right	5.97
	Spring (March - May)	Summer (June - August)	(September - November) Fall	Winter (December - February)
Unit Maintenance Rating (Fall Only)			U	
Date of Inspection	04/17/2012 - 04/17/2012		11/21/2012 - 11/21/2012	
DWR Inspector	John Williamson		John Williamson	
Accompanied By	Regina Espinosa Yolo County		Regina Espinosa Yolo County	
	Chris Starke Yolo County		Chris Starke Yolo County

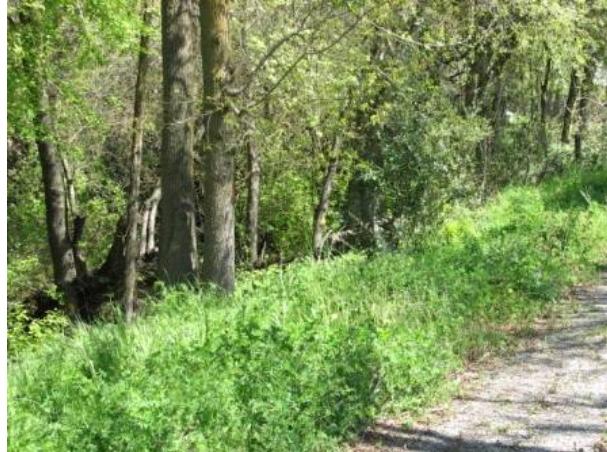
Levee Mile Report Line	4
Start Levee Mile	0.03
End Levee Mile	0.20
Location	Water Side
Category	Earthen Levee
Item	Vegetation
Remove all brush except grasses.

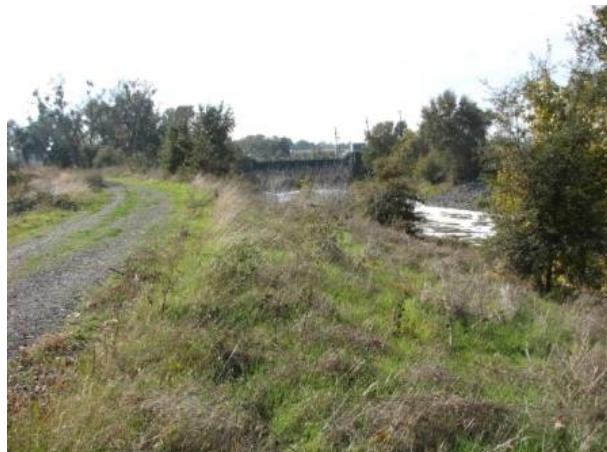
Levee Mile Report Line	4
Start Levee Mile	0.03
End Levee Mile	0.20
Location	Water Side
Category	Earthen Levee
Item	Vegetation
Grasses are taller than 12 inches with brush that obstruct the view. Fall 2011

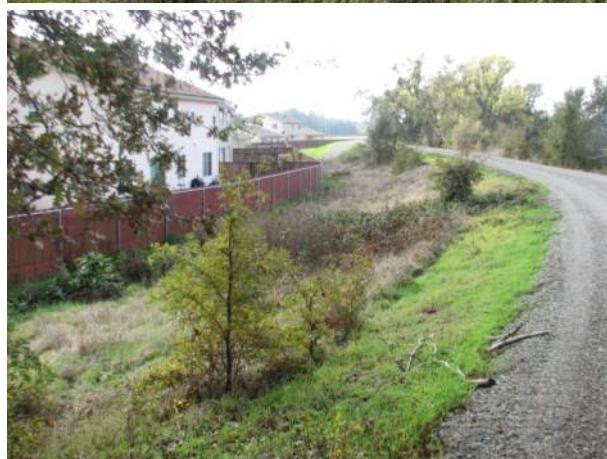
Levee Mile Report Line	5
Start Levee Mile	0.06
End Levee Mile	0.09
Location	Land Side
Category	Earthen Levee
Item	Vegetation
Trees and berries are on the landside slope. Fall 2012

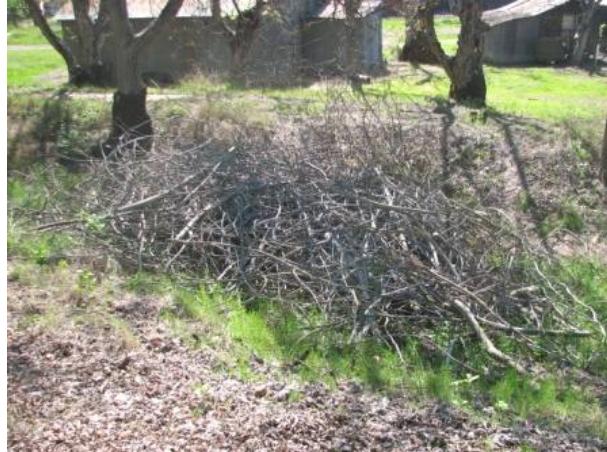
Levee Mile Report Line	6
Start Levee Mile	0.15
End Levee Mile	0.15
Location	Land Side
Category	Earthen Levee
Item	Encroachments
Pruings from the fig tree left at toe. Photo taken spring 2012.	johngw_f_20120911_294.jpg

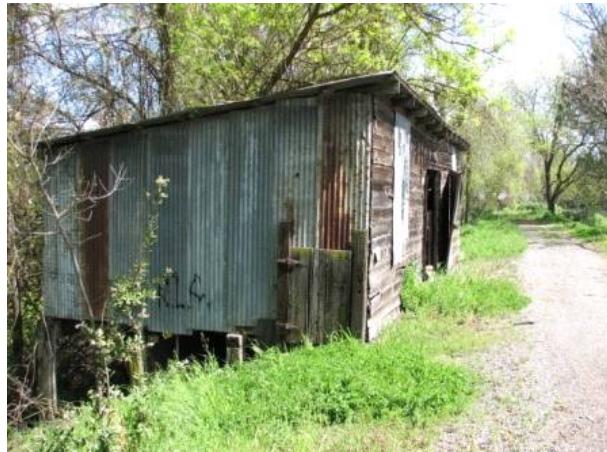
Levee Mile Report Line	7
Start Levee Mile	0.15
End Levee Mile	0.15
Location	Water Side
Category	Earthen Levee
Item	Encroachments
Building on waterside.	johngw_f_20120911_311.jpg

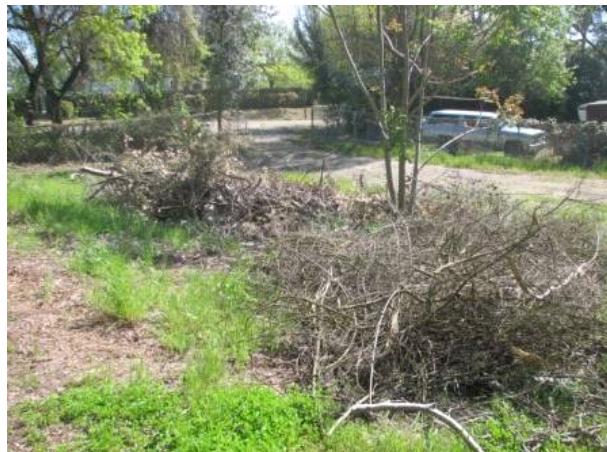
Levee Mile Report Line	8
Start Levee Mile	0.18
End Levee Mile	0.18
Location	Land Side
Category	Earthen Levee
Item	Encroachments
Piles of pruning and debris at toe. Photo taken spring 2012.	johngw_f_20120911_298.jpg

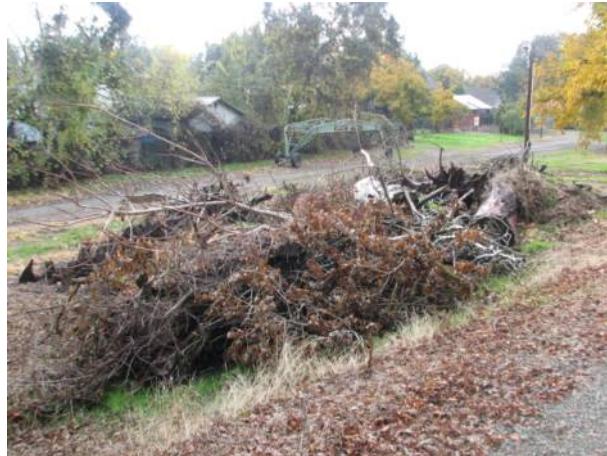
Levee Mile Report Line	8
Start Levee Mile	0.18
End Levee Mile	0.18
Location	Land Side
Category	Earthen Levee
Item	Encroachments
The pruning pile is growing from last inspection. Fall 2012	
<i>johngw_f_20121126_878.jpg</i>

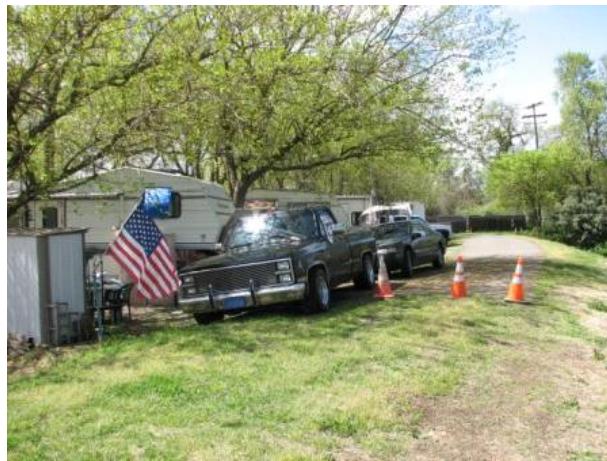
Levee Mile Report Line	9
Start Levee Mile	0.22
End Levee Mile	0.26
Location	Land Side
Category	Earthen Levee
Item	Encroachments
RV park trailers and vehicles on levee.	
<i>johngw_f_20120911_310.jpg</i>

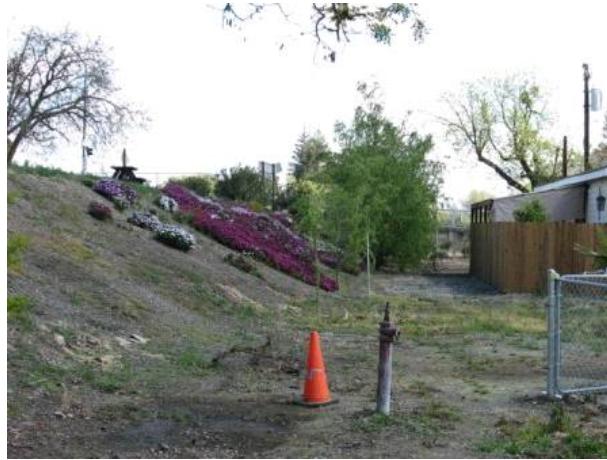
Levee Mile Report Line	10
Start Levee Mile	0.31
End Levee Mile	0.33
Location	Land Side
Category	Earthen Levee
Item	Vegetation
Landscaping on levee slope.	
<i>johngw_f_20120911_309.jpg</i>

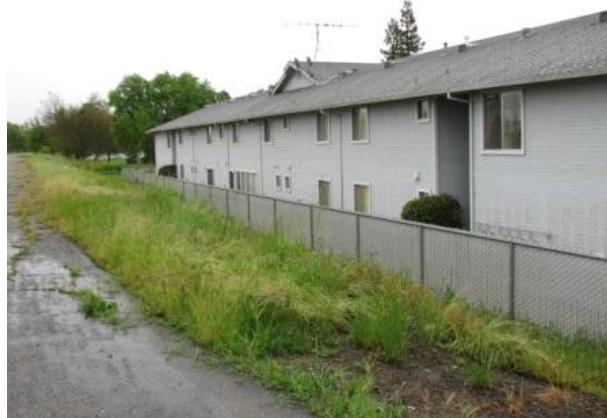
Levee Mile Report Line	11
Start Levee Mile	0.35
End Levee Mile	0.39
Location	Land Side
Category	Earthen Levee
Item	Encroachments
Apartments and fence.	
<i>johngw_f_20120911_307.jpg</i>

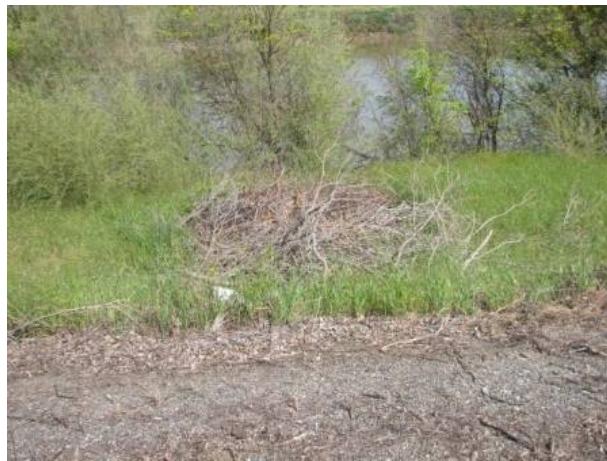
Levee Mile Report Line	12
Start Levee Mile	0.43
End Levee Mile	0.43
Location	Water Side
Category	Earthen Levee
Item	Encroachments
Piles of prunings on waterside toe, photo taken spring 2012.	
<i>johngw_f_20120911_299.jpg</i>

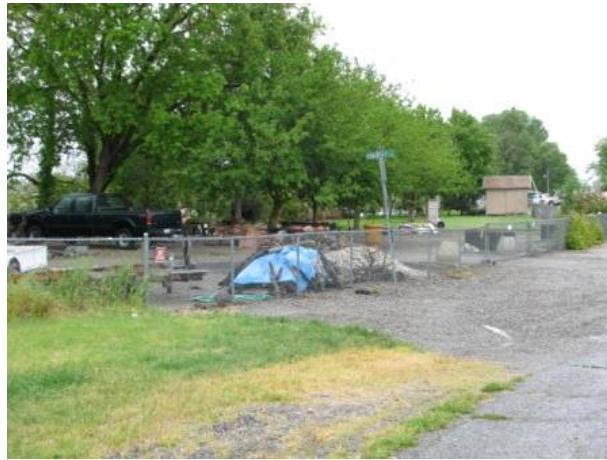
Levee Mile Report Line	13
Start Levee Mile	0.50
End Levee Mile	0.57
Location	Water Side
Category	Earthen Levee
Item	Vegetation
On levee crown.	
<i>johngw_f_20120911_305.jpg</i>

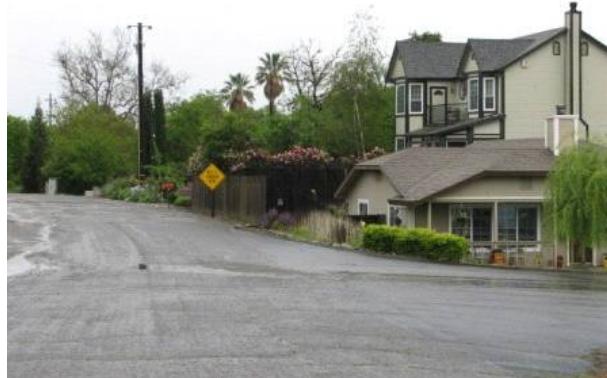
Levee Mile Report Line	14
Start Levee Mile	0.51
End Levee Mile	0.57
Location	Land Side
Category	Earthen Levee
Item	Encroachments
Houses on levee.	johngw_f_20120911_306.jpg

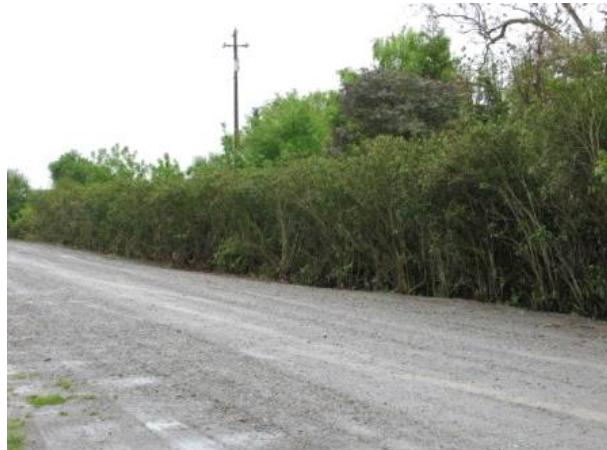
Levee Mile Report Line	15
Start Levee Mile	0.57
End Levee Mile	0.71
Location	Land Side
Category	Earthen Levee
Item	Vegetation
Oleanders along the shoulder.	johngw_f_20120911_303.jpg

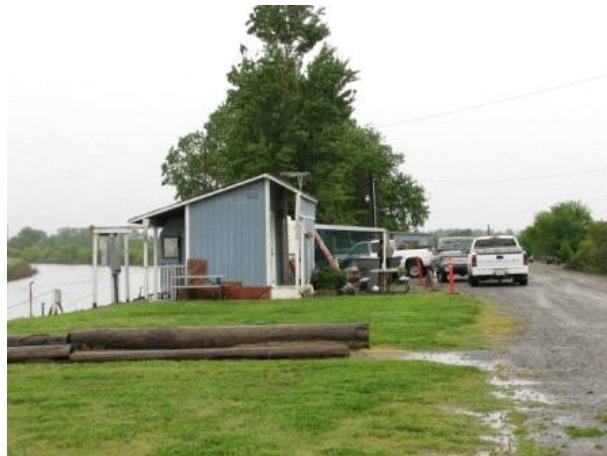
Levee Mile Report Line	16
Start Levee Mile	0.57
End Levee Mile	0.65
Location	Water Side
Category	Earthen Levee
Item	Encroachments
Yacht club.	johngw_f_20120911_304.jpg

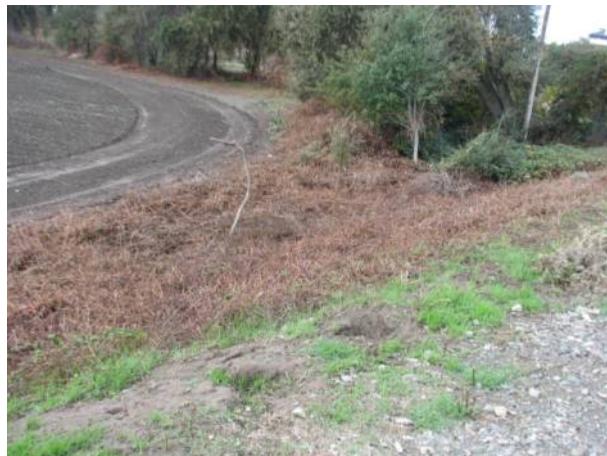
Levee Mile Report Line	17
Start Levee Mile	0.73
End Levee Mile	0.73
Location	Land Side
Category	Earthen Levee
Item	Vegetation

A current view of the berries, they have been cut down. Fall 2012

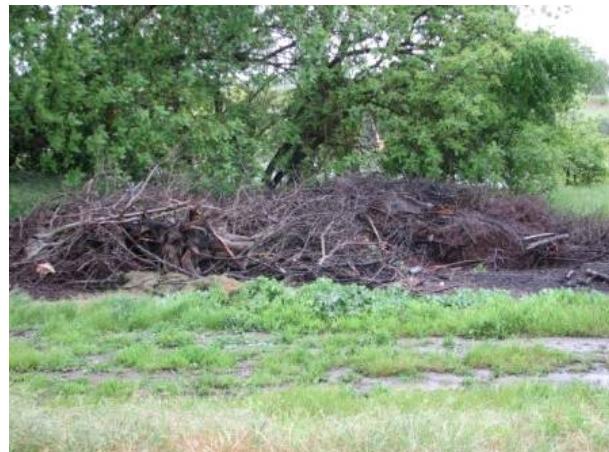
Levee Mile Report Line	20
Start Levee Mile	1.78
End Levee Mile	1.78
Location	Water Side
Category	Earthen Levee
Item	Encroachments

Prunings

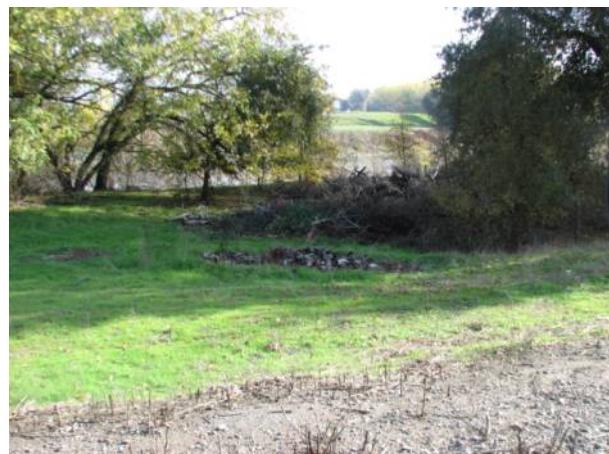
Levee Mile Report Line	20
Start Levee Mile	1.78
End Levee Mile	1.78
Location	Water Side
Category	Earthen Levee
Item	Encroachments

The pile has been burned but there is a small pile beyond the slope. Fall 2012

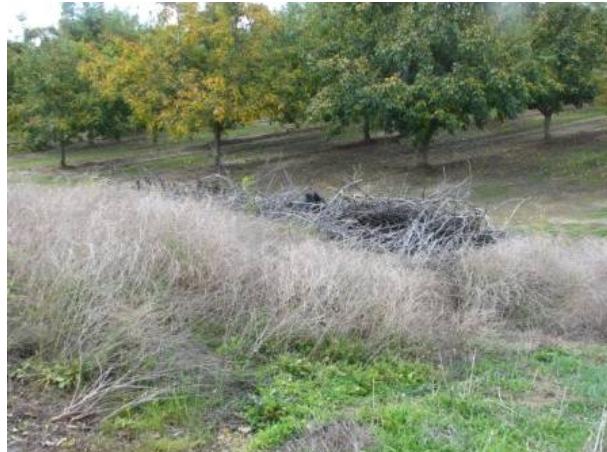
Levee Mile Report Line	22
Start Levee Mile	1.99
End Levee Mile	1.99
Location	Land Side
Category	Earthen Levee
Item	Encroachments
A pile of prunings is stacked on the levee slope near the toe. Fall 2011	
<i>johngw_f_20120911_325.jpg</i>

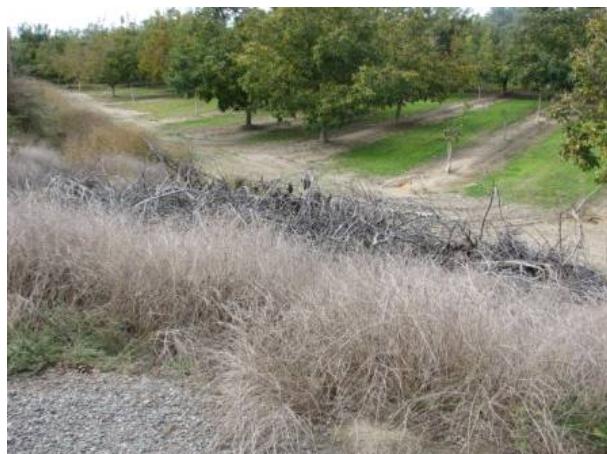
Levee Mile Report Line	24
Start Levee Mile	2.06
End Levee Mile	2.06
Location	Land Side
Category	Earthen Levee
Item	Encroachments
Another pile of prunings is stacked on the levee slope. Fall 2011	
<i>johngw_f_20120911_327.jpg</i>

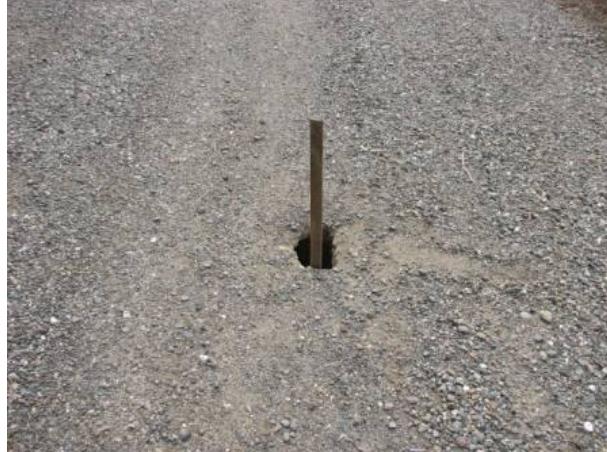
Levee Mile Report Line	25
Start Levee Mile	2.07
End Levee Mile	2.07
Location	Crown
Category	Earthen Levee
Item	Animal Control
A rodent hole in the crown of the levee. Fall 2011	
<i>johngw_f_20120911_328.jpg</i>

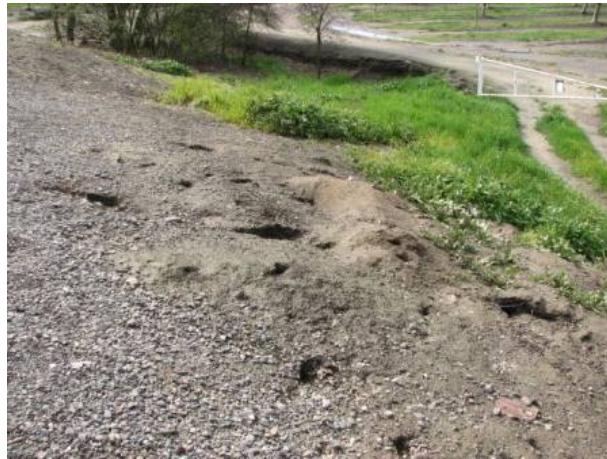
Levee Mile Report Line	26
Start Levee Mile	2.18
End Levee Mile	2.18
Location	Land Side
Category	Earthen Levee
Item	Animal Control
There are multiple rodent holes but no visible rodents. Need to backfill and compact.	
<i>johngw_f_20120911_290.jpg</i>

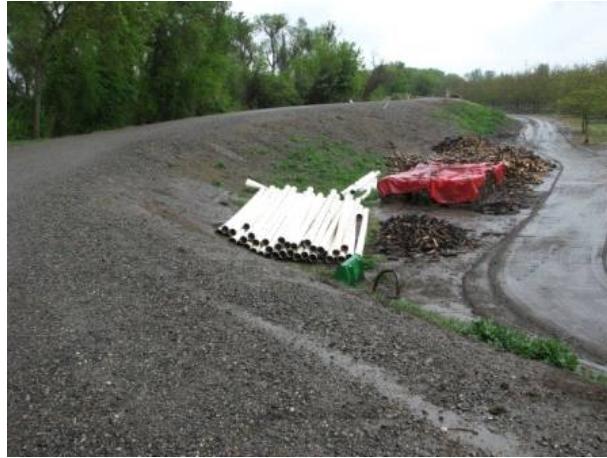
Levee Mile Report Line	27
Start Levee Mile	2.22
End Levee Mile	2.22
Location	Land Side
Category	Earthen Levee
Item	Encroachments
Pipe along toe.	
<i>johngw_f_20120911_321.jpg</i>

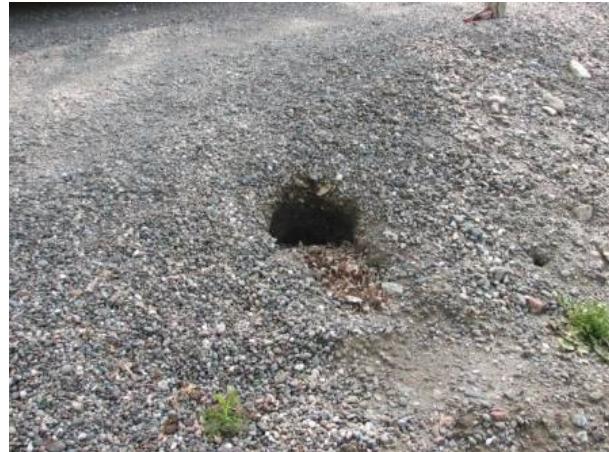
28	2.22	2.22	Earthen Levee	Animal Control	LS M	A3 : No rodents visible, but rodent burrows visible; need to Ma	backfill and compact or grout burrows.			38.792428 ° 38.792428 ° 35 -121.695495 ° -121.695495 ° Y DWR ID: DWR_NA0022_01_s_2012_35

Levee Mile Report Line	28
Start Levee Mile	2.22
End Levee Mile	2.22
Location	Land Side
Category	Earthen Levee
Item	Animal Control
A rodent hole needs to be backfilled and compacted.	johngw_f_20120911_316.jpg

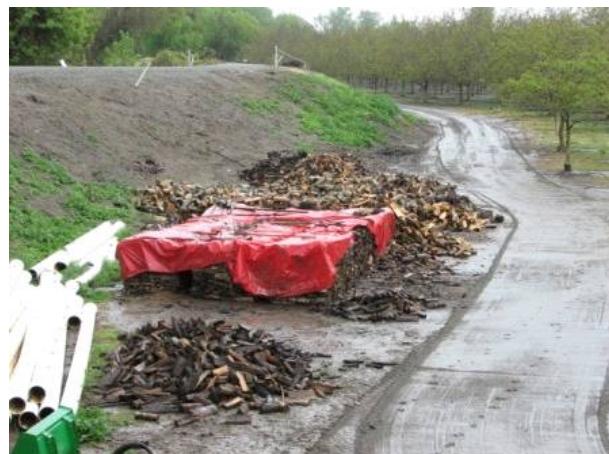
Levee Mile Report Line	29
Start Levee Mile	2.24
End Levee Mile	2.24
Location	Land Side
Category	Earthen Levee
Item	Encroachments
Firewood stacked up.	johngw_f_20120911_320.jpg

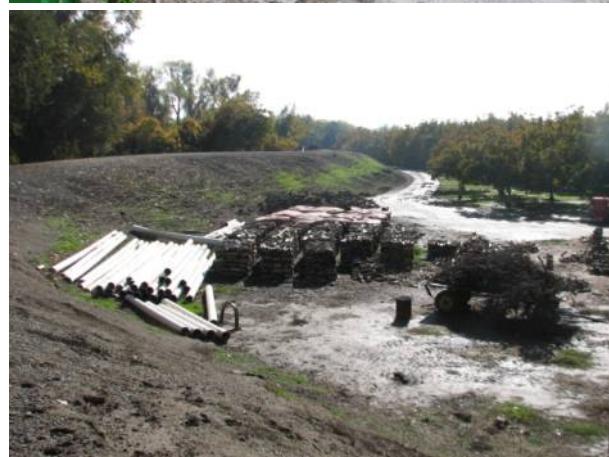
Levee Mile Report Line	29
Start Levee Mile	2.24
End Levee Mile	2.24
Location	Land Side
Category	Earthen Levee
Item	Encroachments
The firewood pile is continuing to grow along the toe of the levee. Fall 2012	johngw_f_20121126_882.jpg

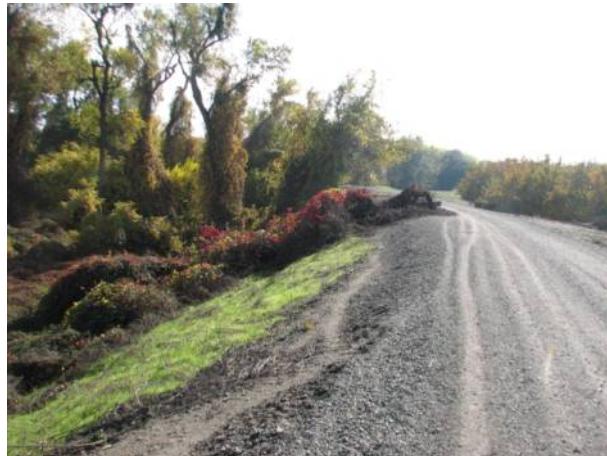
The tree is on the waterside levee slope and shoulder. Fall 2012

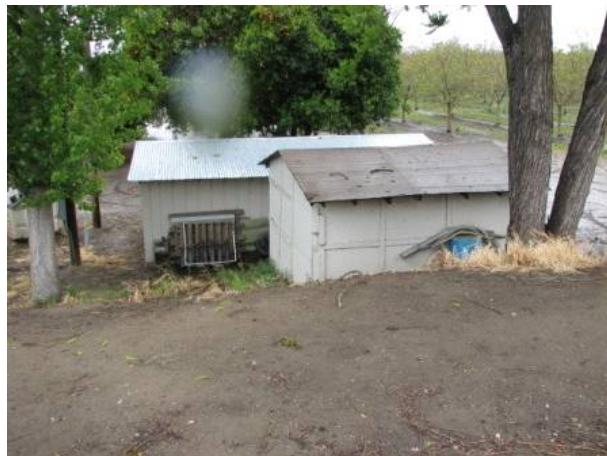
Garage at toe.

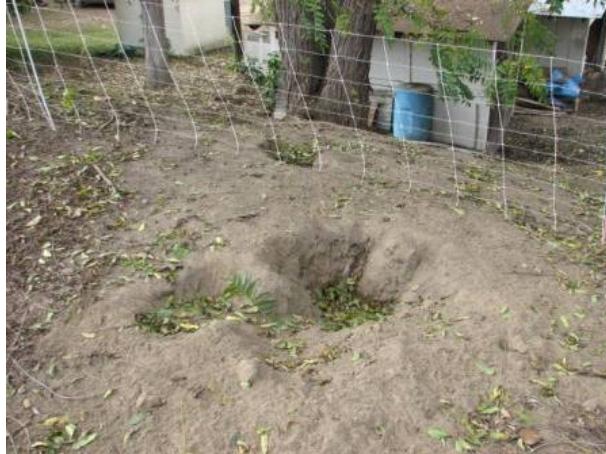
Levee Mile Report Line	33
Start Levee Mile	2.62
End Levee Mile	2.62
Location	Crown
Category	Earthen Levee
Item	Animal Control
A very large rodent hole at the shoulder of the levee. Fall 2011	
johngw_f_20120911_329.jpg

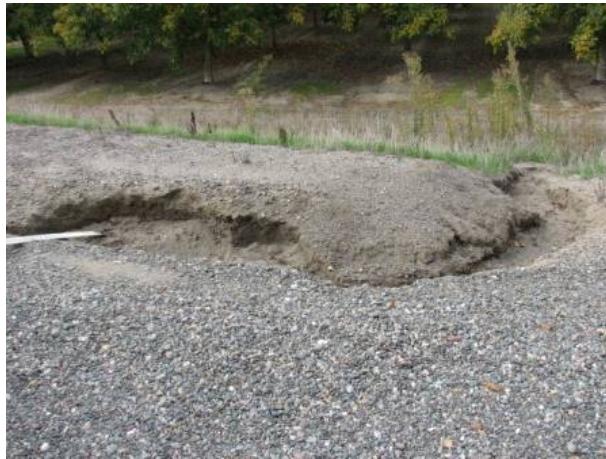
Levee Mile Report Line	34
Start Levee Mile	2.72
End Levee Mile	2.72
Location	Land Side
Category	Earthen Levee
Item	Erosion / Bank Caving
Erosion caused by a build up of water then running off the slope. Fall 2011	
johngw_f_20120911_330.jpg

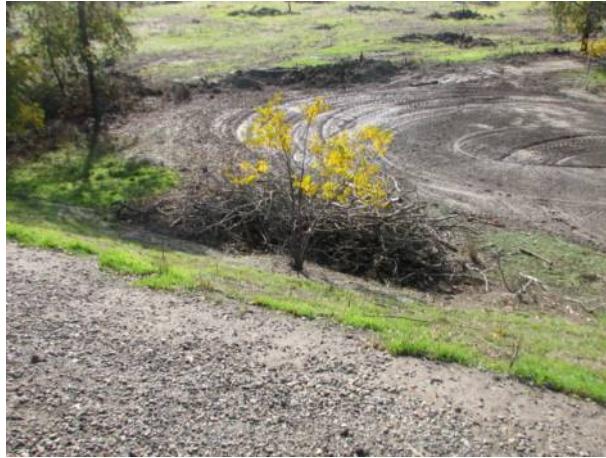
Levee Mile Report Line	35
Start Levee Mile	2.97
End Levee Mile	2.97
Location	Land Side
Category	Earthen Levee
Item	Encroachments
A pruning pile at the toe. Fall 2012	
johngw_f_20121126_884.jpg

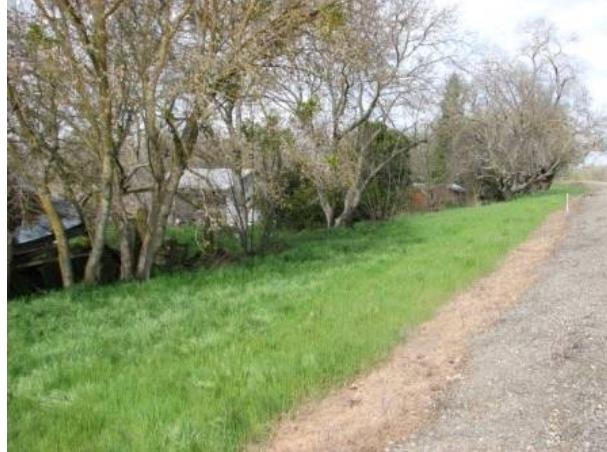
Levee Mile Report Line	36
Start Levee Mile	3.12
End Levee Mile	3.19
Location	Land Side
Category	Earthen Levee
Item	Encroachments
The buildings are encroaching into the levee slope.	
<i>johngw_f_20120911_293.jpg</i>

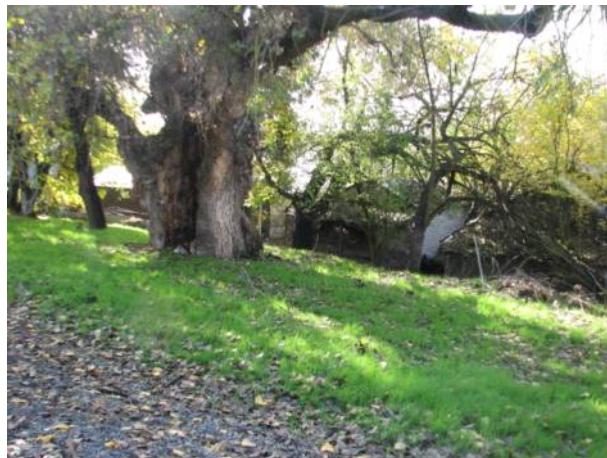
Levee Mile Report Line	36
Start Levee Mile	3.12
End Levee Mile	3.19
Location	Land Side
Category	Earthen Levee
Item	Encroachments
Buildings are located at the toe of the levee. Fall 2012	
<i>johngw_f_20121126_885.jpg</i>

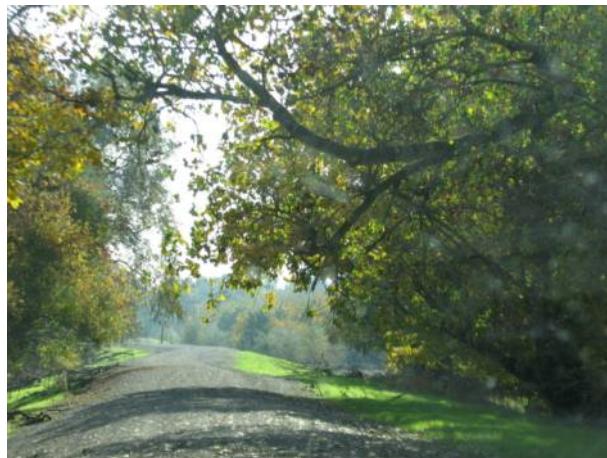
Levee Mile Report Line	37
Start Levee Mile	3.12
End Levee Mile	3.12
Location	Crown
Category	Earthen Levee
Item	Trim / Thin Trees
Trees need to be trimmed to the height of 12 feet. Fall 2012	
<i>johngw_f_20121126_886.jpg</i>

37	3.12	3.12	Earthen Levee	Trim / Thin Trees	CR Ma	M	T4 : Trim trees over roadway to at least 12 feet above ground level.	38.781737 °	38.781737 °	14	
								-121.689362 °	-121.689362 °	Y	DWR ID: DWR_NA0022_01_f_2012_14
38	3.13	3.38	Earthen Levee	Encroachments	WS Ma	M	PR : Prunings	38.781676 °	38.778376 °	30	
								-121.689327 °	-121.687447 °	Y	DWR ID: DWR_NA0022_01_f_2012_30
39	3.18	3.28	Supplemental USACE Erosion Survey	WS Ma	M		Inspector Comments: 2006 - Short section is into the levee toe, rest is near the levee toe. Mass failure and fluvial erosion of depositional material. Rock at the upstream and downstream ends. 2011 - Minor new erosion. 2012: No observed change. [2012 Site ID: SAC_86-9_R]	38.780407 °	38.779137 °	3	
								-121.688238 °	-121.687432 °	Y	DWR ID:
40	3.25	3.25	Earthen Levee	Trim / Thin Trees	WS Ma	M	T3 : Trim and thin trees to allow visibility of the ground and room to flood fight. Inspector Comments: Dead tree broken during winter storms, needs to be cleaned up.	38.780041 °	38.780041 °	15

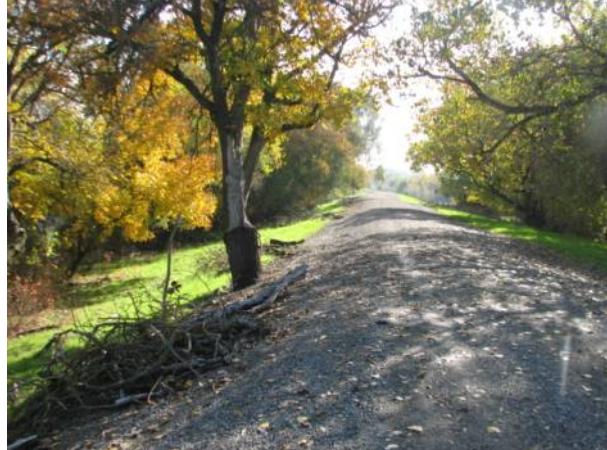
Levee Mile Report Line	38
Start Levee Mile	3.13
End Levee Mile	3.38
Location	Water Side
Category	Earthen Levee
Item	Encroachments
Piles of prunings are on the waterside slope. Fall 2012	
johngw_f_20121126_887.jpg

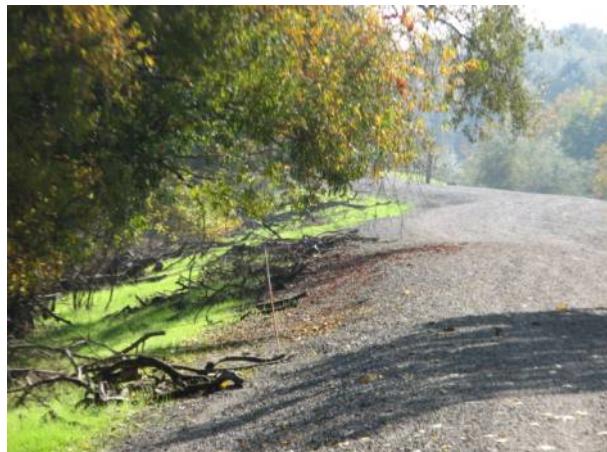
Levee Mile Report Line	38
Start Levee Mile	3.13
End Levee Mile	3.38
Location	Water Side
Category	Earthen Levee
Item	Encroachments
Many piles are on the slope. Fall 2012.	
johngw_f_20121126_888.jpg

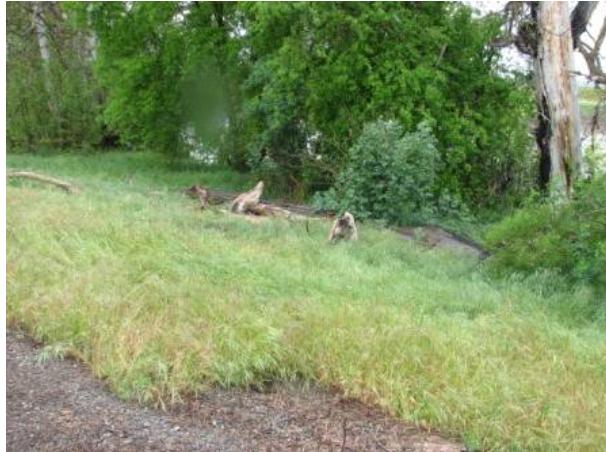
Branches from dead trees, water side.

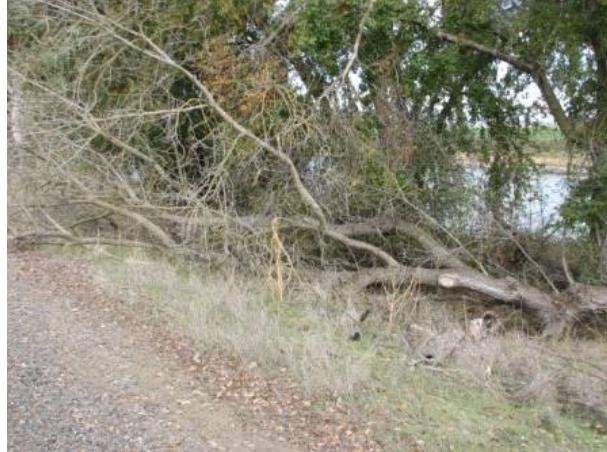
Levee Mile Report Line	41
Start Levee Mile	3.31
End Levee Mile	3.31
Location	Water Side
Category	Earthen Levee
Item	Trim / Thin Trees
A cottonwood tree has fallen over against the slope. Fall 2011	
johngw_f_20120911_296.jpg

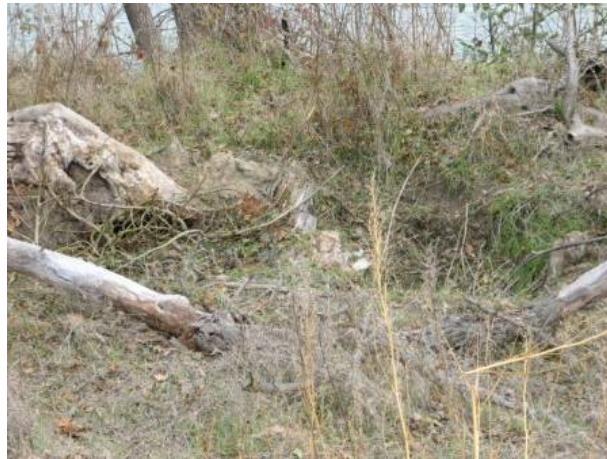
Levee Mile Report Line	41
Start Levee Mile	3.31
End Levee Mile	3.31
Location	Water Side
Category	Earthen Levee
Item	Trim / Thin Trees
This is the root ball of the tree. It has created a large void in the berm. Fall 2011	
johngw_f_20120911_297.jpg

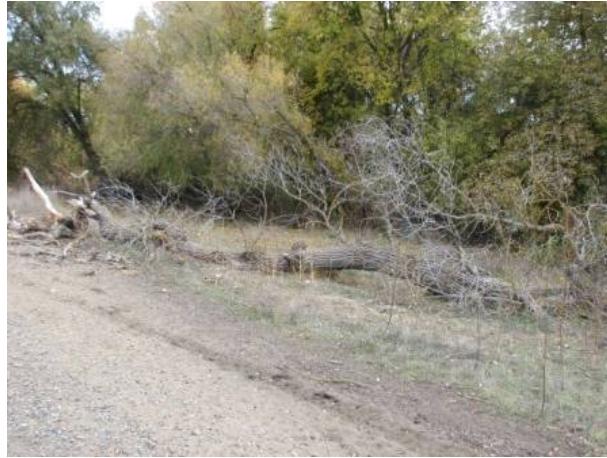
Levee Mile Report Line	43
Start Levee Mile	3.70
End Levee Mile	3.70
Location	Water Side
Category	Earthen Levee
Item	Encroachments
Another tree has fallen on the waterside slope. Fall 2011	
johngw_f_20120911_331.jpg

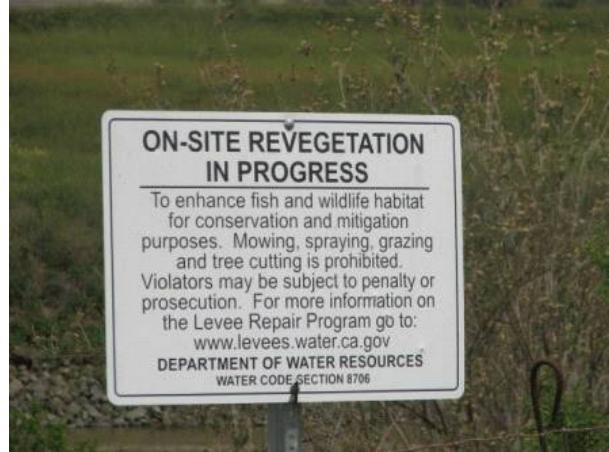
Levee Mile Report Line	44
Start Levee Mile	4.31
End Levee Mile	4.57
Location	Water Side
Category	Earthen Levee
Item	Vegetation
USACE revegetation site photo spring 2012.	johngw_f_20120911_317.jpg

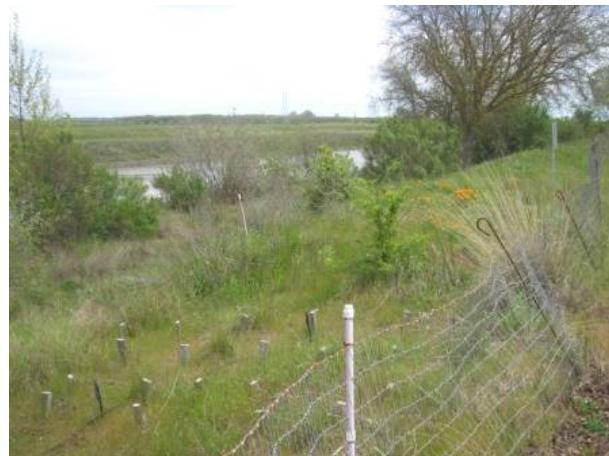
Levee Mile Report Line	44
Start Levee Mile	4.31
End Levee Mile	4.57
Location	Water Side
Category	Earthen Levee
Item	Vegetation
Fence, irrigation and stakes in the revegetation site.	johngw_f_20120911_318.jpg

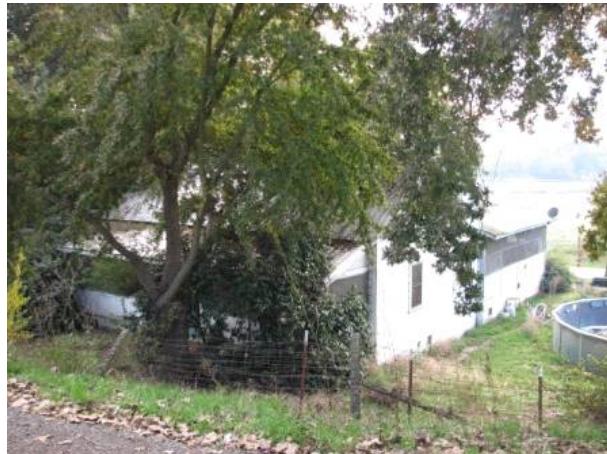
The house and landscape are in the easement of the levee. Fall 2011

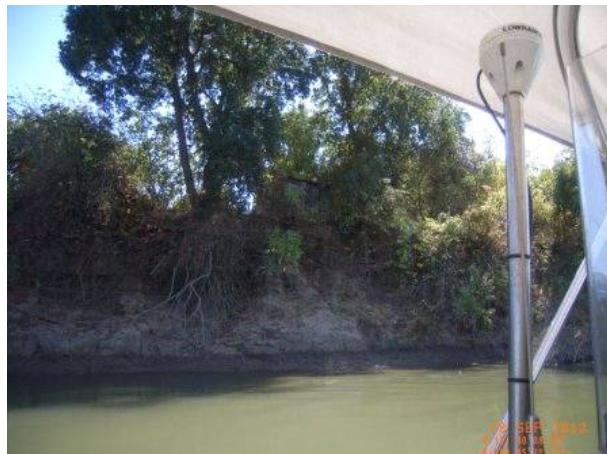
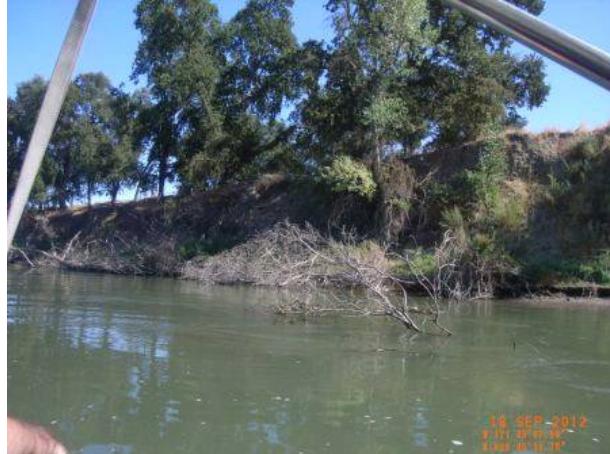
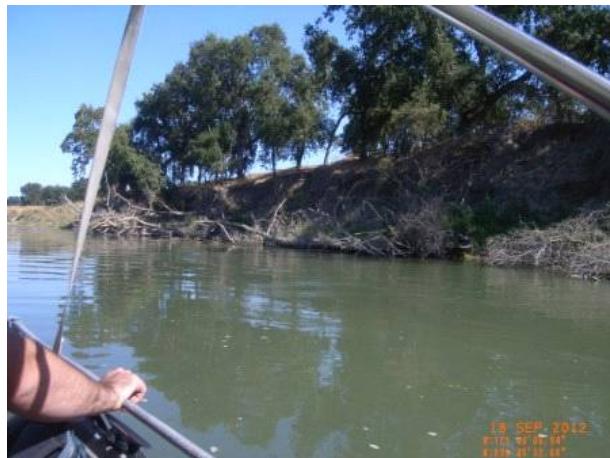
Levee Mile Report Line	47
Start Levee Mile	5.77
End Levee Mile	5.86
Location	Water Side
Category	Supplemental
Item	USACE Erosion Survey
USACE 2012 Photo #2	
USACE2012_SAC_83-9_R_2.jpg

45	4.66	4.86	Supplemental USACE Erosion Survey	WS M Ma	Inspector Comments: 2009 - Erosion into the levee toe. Some cobbles have been dumped into the erosion pockets. 2010 - Old cobble site starting to unravel. 2012: No observed change. [2012 Site ID: SAC_85-4_R]		38.763486 ° -121.687567 °	38.763313 ° -121.684038 °	4	DWR ID:	
46	5.60	5.65	Earthen Levee	Encroachments	LS A/W En	BU : Building	38.759620 ° -121.673903 °	38.759412 ° -121.673167 °	1	DWR ID: DWR_NA0022_01_s_2012_1	
47	5.77	5.86	Supplemental USACE Erosion Survey	WS M Ma	Inspector Comments: 2006 - Approximately 18 to 20 ft of bank near levee at the corner of the levee and the Freemont Weir. Vertical bank with undercutting/mass failure. 2007 - Staked at top of bank for monitoring. 2011 - Site has become significantly worse with more of the toe and lower bank eroded. Many trees have fallen since last year. 2012: Site looks worse with more erosion around trees. [2012 Site ID: SAC_83-9_R]		38.758877 ° -121.669365 °	38.759390 ° -121.667500 °	5	DWR ID:
